Bank of Montreal High-Rise Office Building Case Study

Existing Building Retro-Commissioning (EBCx)

Bank of Montreal Tower Toronto (BMTT) high-rise office building built in 1974

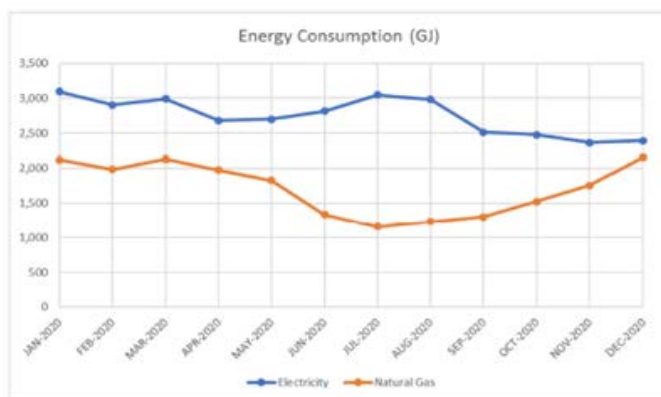
Figure 2: Building Energy Consumption (GJ) Jan-Dec 2020

A summary of the energy utility data from January to December 2020 is also shown above as well for reference.

Utility	Consumption	Cost *	Average Rate *
Electricity	32,947 GJ	\$1,120,436	\$34.01 / GJ
Electricity	9,152,017 kWh	\$1,120,436	\$0.1224 / kWh
Natural gas	20,515 GJ	\$137,762	\$6.54 / GJ

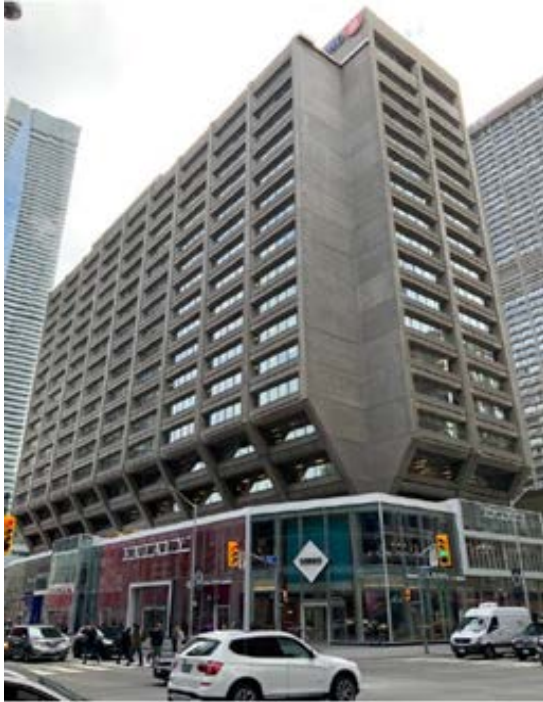
Figure 3: BMTT, North & West Elevations

The building envelope consists of precast concrete cladding, windows, and a flat roof.

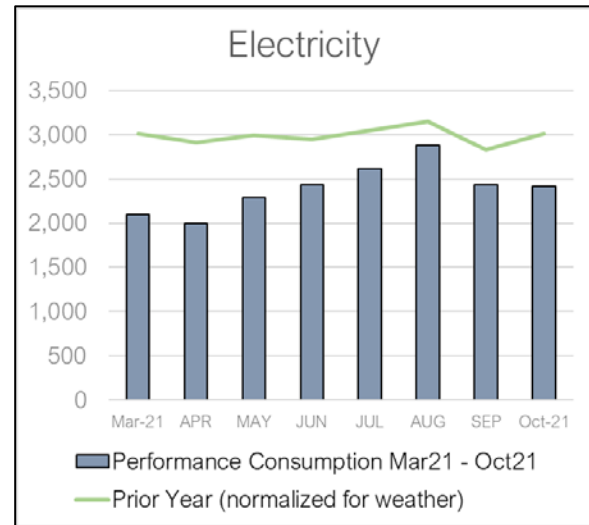
Figure 4: Electricity Consumption (GJ)

The electricity consumption savings attributed to the EBCx is 4,737GJ (20%) and approximately \$161,110 when comparing the months of March - October 2021 to March - October 2020.

Energy consumption savings calculations are shown in Figures 3 and 4. BGIS used Option C from the International Performance Measurement and Verification Protocol (IPMVP) to compare the whole building energy to the same period in 2020 normalized/adjusted for 2021 weather. Occupancy assumptions did not change from the baseline as the occupancy was similar through these two time periods during the COVID-19 pandemic.

Actual utility bills were collected and uploaded into a BGIS utility bill analysis tool to measure the results from March-October 2021 relative to March-October 2020, and then normalized for 2021 weather using a weather regression model specific to the building.

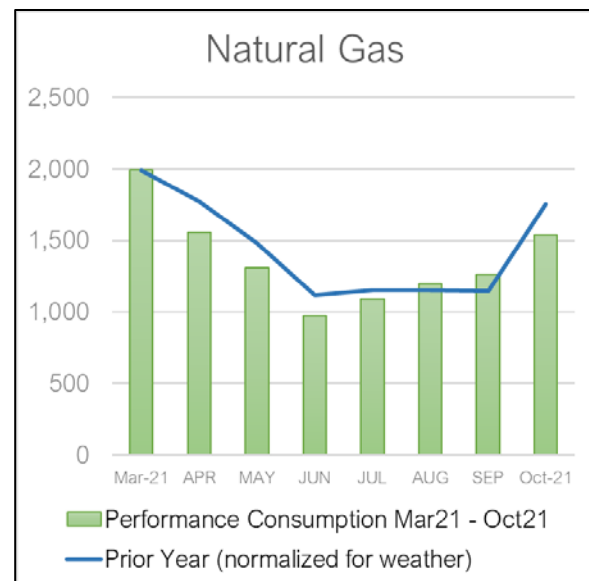
Figure 5: Natural Gas Consumption (GJ)

The natural gas consumption savings attributed to the EBCx is 647 GJ (6%) and approximately \$4,230 when comparing the months of March - October 2021 to March -October 2020.
